6. POSSIBLE FAILURES

6.1. POSSIBLE FAILURES OF COUPLING

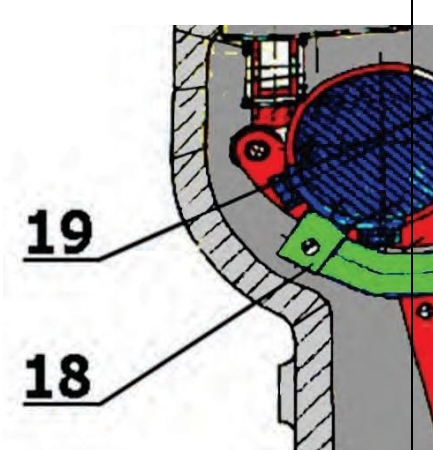
4. The pump will not unload after the uplift completion in transport position of the linkage.	The position of the swing levers with regard to the limit stop 19 of the position sensor 18 is disturbed.	<p>Detach the lifting rods of the linkage from the swing levers of the hydraulic hoist.</p> <p>Do the bolts on the turn shaft ends out.</p>

<p>After the uplift is completed there comes a distinctive noise from the pump, running the max. pressure, the failure becomes apparent only with the linkage fully uplifted (the pump will unload as the uplift is incomplete)</p>		<p>Take the swing levers off the splines and displace them by one spline down to the cylinder direction.</p> <p>Lock the swing levers on the shaft with the plates, doing the bolts in.</p>

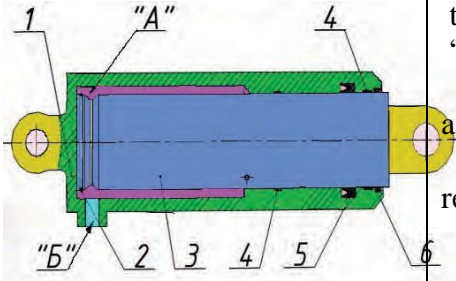
<p>7. The weighted linkage goes down by itself with the engine killed (or with the pump turned off).</p> <p>“Often” correction. Oil heating is possible.</p> <p>Outer leakage of oil over the plunger of one or both cylinders.</p>	<p>Failure of gaskets 5 of actuating cylinders</p>

<p>Take the plunger 3 out of the casing 1, having previously transferred the lock ring 2 to the mounting groove “A”.</p> <p>Replace the gasket 5 having arranged it as shown in the figure.</p> <p>Assemble the cylinder in a reverse order.</p>
<p>8. High vibration of the linkage when lowering the implement.</p> <p>May occur when heavy implements with 2000kg weight are lowered.</p>	<p>Fracture or shrinking of the spring 19 of the slowdown valve 18.</p> <p>Fracture of limit stop 20.</p>	<p>Take the distributing valve group off the hydraulic hoist;</p> <p>Squeeze the pull-back spring 17 to release the dowel 16 and take it out of the hole in the spool 13, hereby holding the outer limit stop 15.</p>

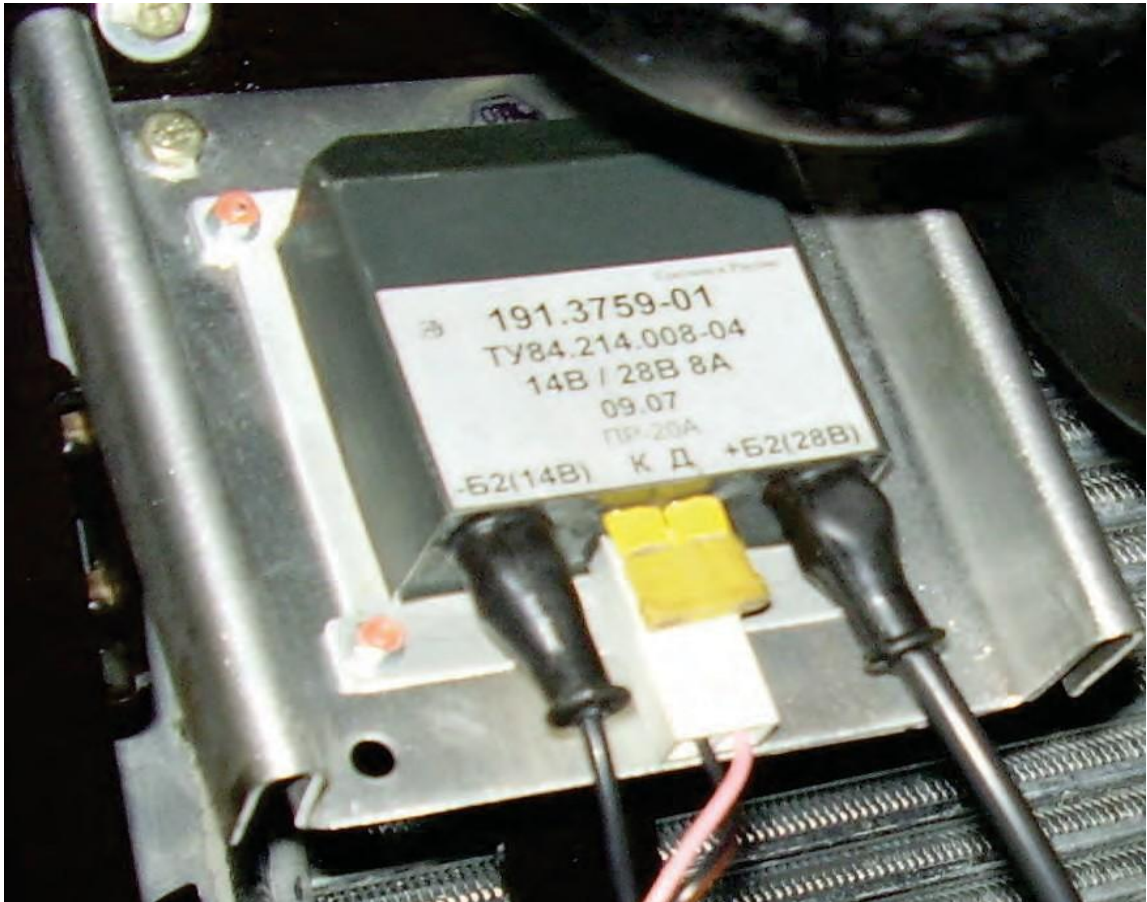
Figure 6.11

Power supply system

The voltage converter UZ1 is an electronic device intended to charge the second battery GB2 by converting and adjusting charge voltage, its operation is based on the principle of conversion.

The converter stable operation depends on availability of a non-faulty negative circuit on the converter body.

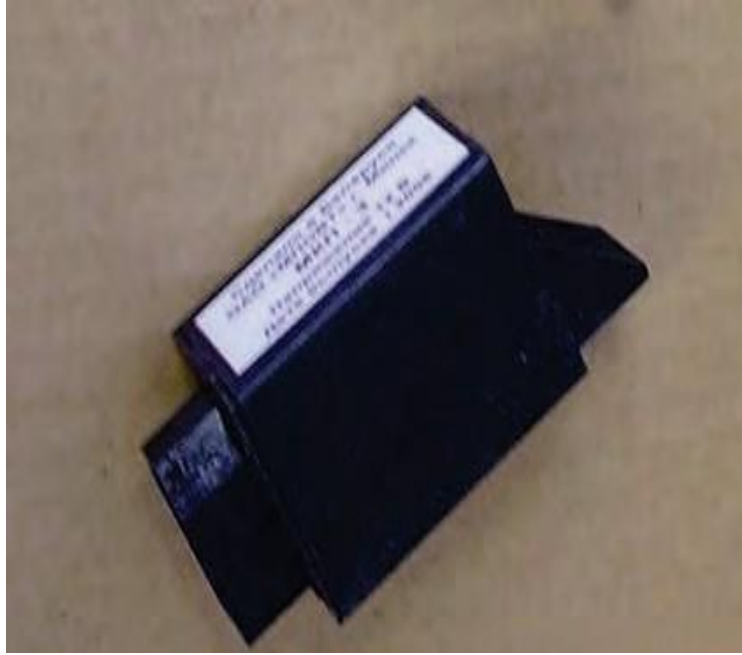
Figure 6.16

KT1 (for 1523 series in the relay box on the engine)
(for 920/952/1021/1025 series in the dashboard)

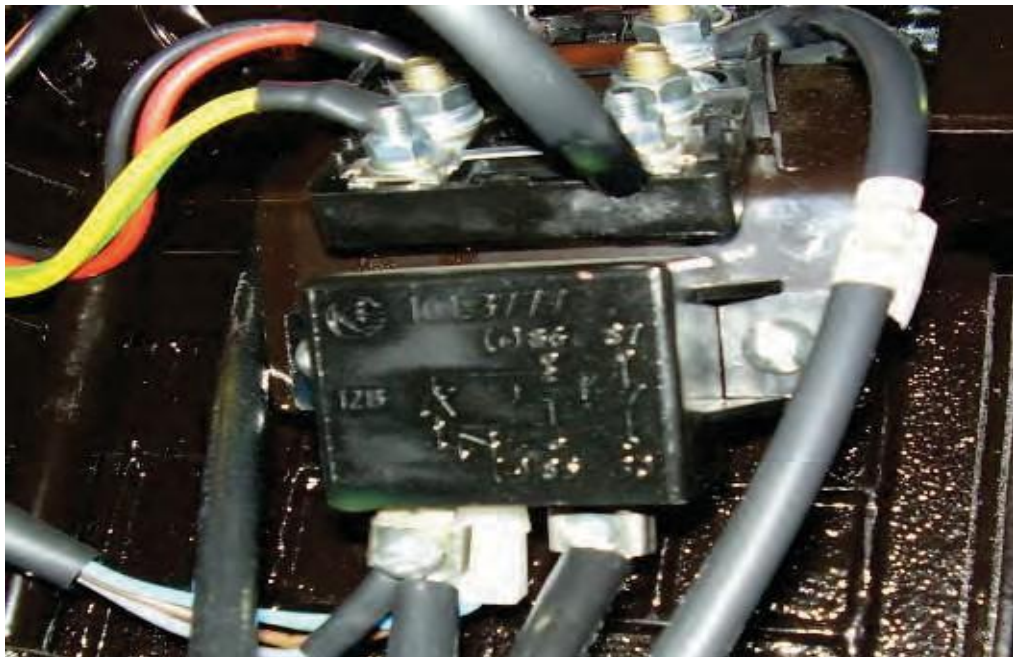
Figure 6.17

K1 (for 1523 series in the relay box on the engine)
(for 920/952/1021/1025 series on the oil tank)
